The Effects of Mechanised Log Skidding on some Components of Farm Tractors in Ondo State, Nigeria

Richard Omoyele Akinbamowo, Basil Oluwafemi Akinnuli

Abstract

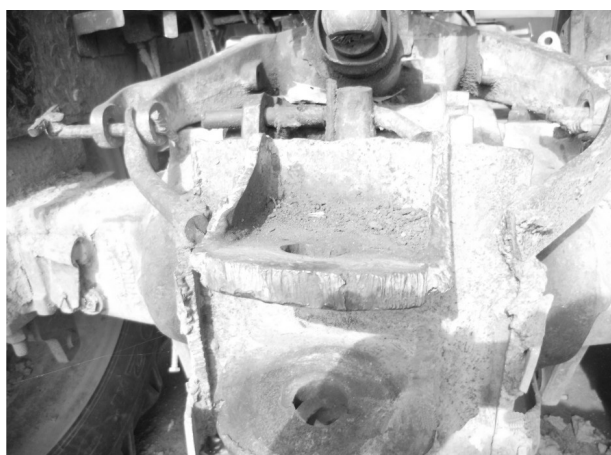
Analysis of the condition of tractor drawbars shows that the drawbar bracket of 43.3% of the tractors was in good condition, 40% of those brackets were

Fig. 2 Damaged drawbar bracket of Massey Ferguson 375 tractor

critically bad (Fig. 2), while 13.3% were faulty but serviceable. The status of few (3.3%) of them were not known. This result might be the outcome of improvisation of winches, converting drawbar brackets to hitch point as commonly practised by operators during log skidding. With respect to missing hooks and pins, majority (46.7%) of the tractors reported them missing, 36.7% were partly missing, while few (13.3%) were in good condition. The status of only 3.3% of them was not known. Thus, the drawbar status of most tractors is averagely poor.

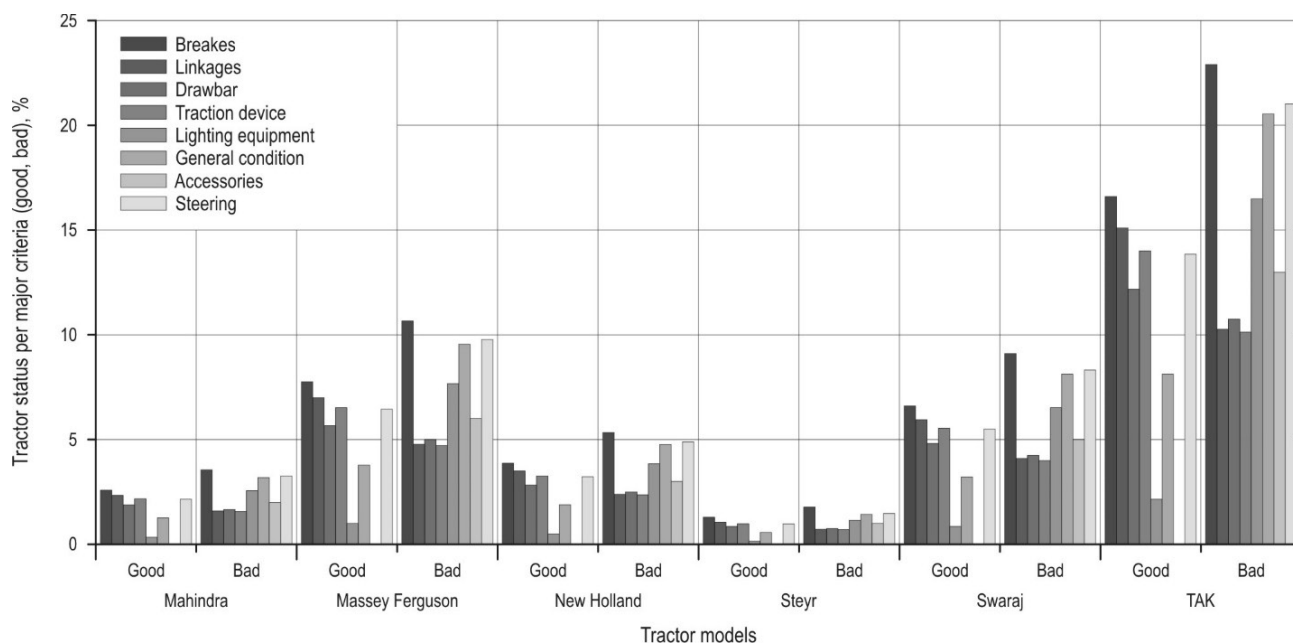
Fig. 3 Analysis of tractor component failure on good/bad basis

Analysing on the basis of mean percentages of major criteria (components and symptoms) and aggregating to strictly good and bad scores on tractor basis and ignoring undisclosed responses, the results (Fig. 3) indicated that the braking unit had a good/bad ratio of 0.72, the linkages 1.47, drawbar 1.13, traction devices 1.38, while the good/bad ratio of the lighting, general physical condition and steering was 0.13, 0.40 and 0.66, respectively.
