Effects of Reduced Tyre Pressures on Wear of Thin-Surfaced Roads

Mikael Bergqvist, Rolf Björheden, Lars Eliasson

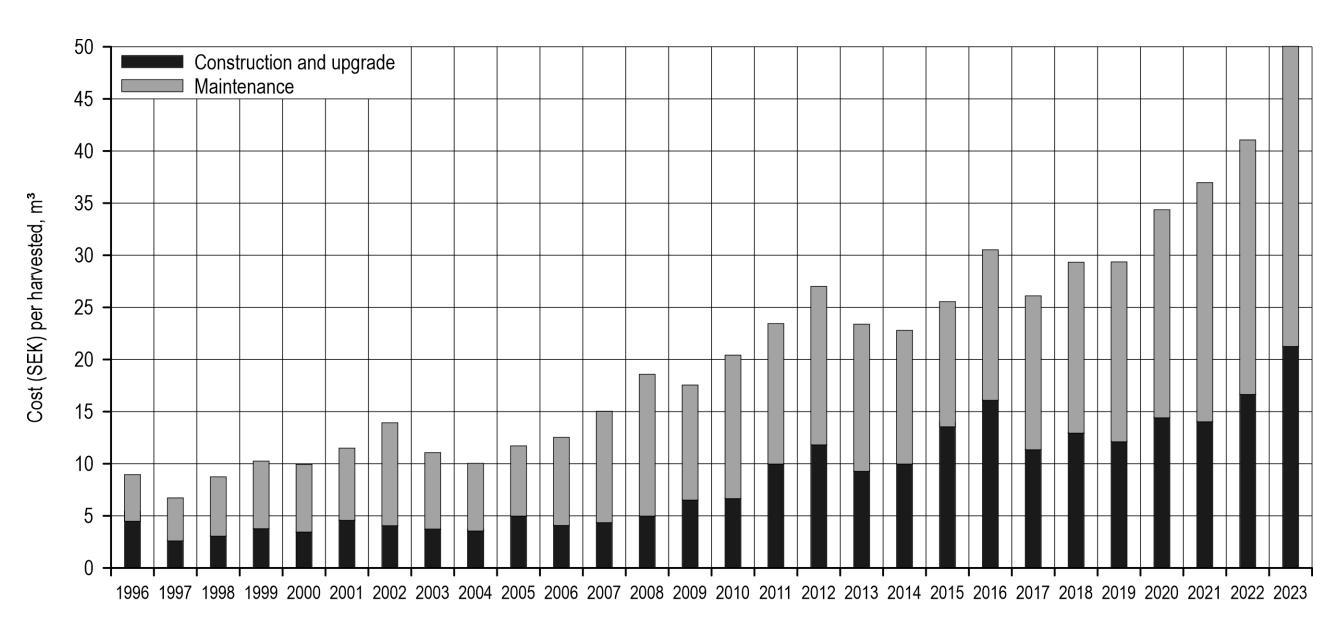
Fig. 1 Development of forest road costs (SEK per m³) for large scale forest owners split to costs for new construction including standard improvements and maintenance costs from 1996 to 2023 (Eliasson 2024)

An increasing importance of road network accessibility, caused by greater requirements for precision in deliveries to customers and financial penalties if the agreed delivery volumes are not met, is enhancing the need for high standard roads. Climate models indicate further reductions of the periods with frozen road conditions in Fenno-Scandia (Lehtonen et al. 2019) and North America (Daniel et al. 2018). This will decrease the amount of wood that can be transported on roads that are only accessible in winter conditions. Consequently, a larger share of the road network needs to be accessible regardless of weather conditions to enable the wood supply organisations to deliver agreed amounts of wood to the industry at the agreed time. This leads to increasing costs for standard improvements of existing roads and construction of new roads per harvested cubic metre (Fig. 1, Eliasson 2024).

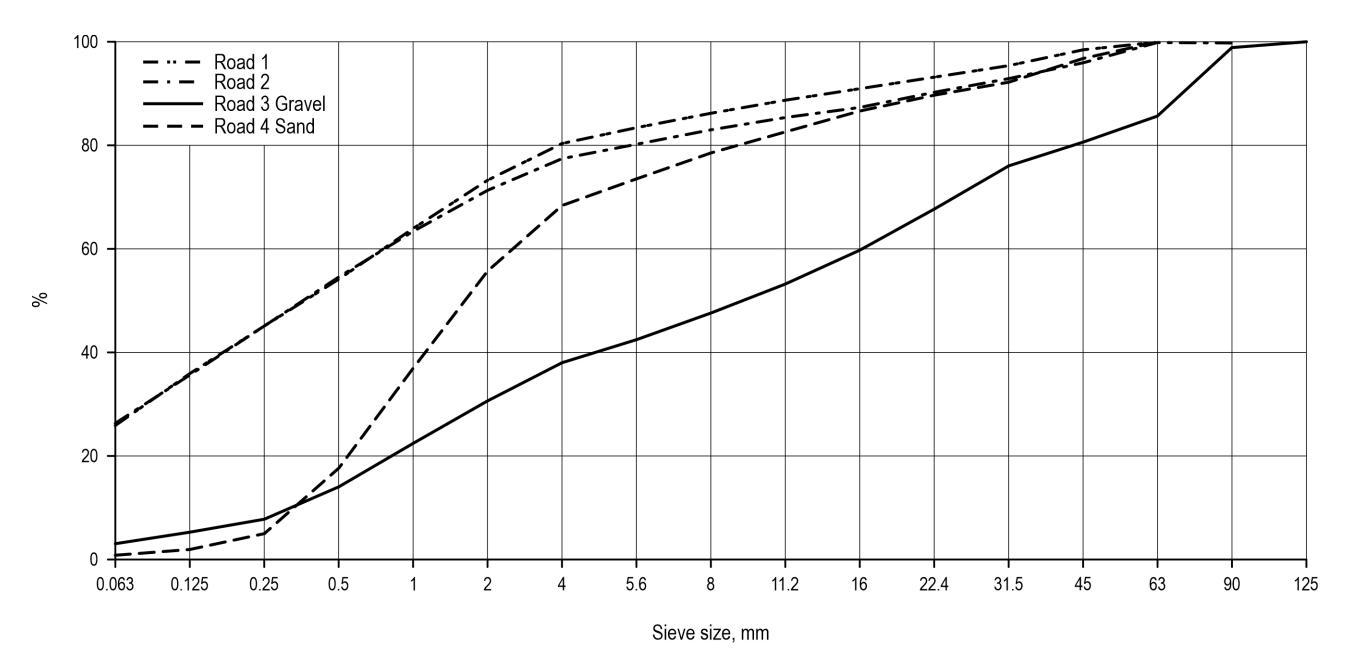
Fig. 3 Particle size distribution for in situ material (subgrade) used for terrace

according to SS-EN 933-1. While there were no variations in the subgrade within Roads 1 and 2, this was not the case for Road 3. It had a subgrade that consisted of well drained sands and gravels with a low proportion of fine-grained material. The material was layered and very varied, leading to a variation between sections, were sections 1 and 6 were situated on poorly graded sands and the remaining sections on well graded gravel soils (Fig. 3).

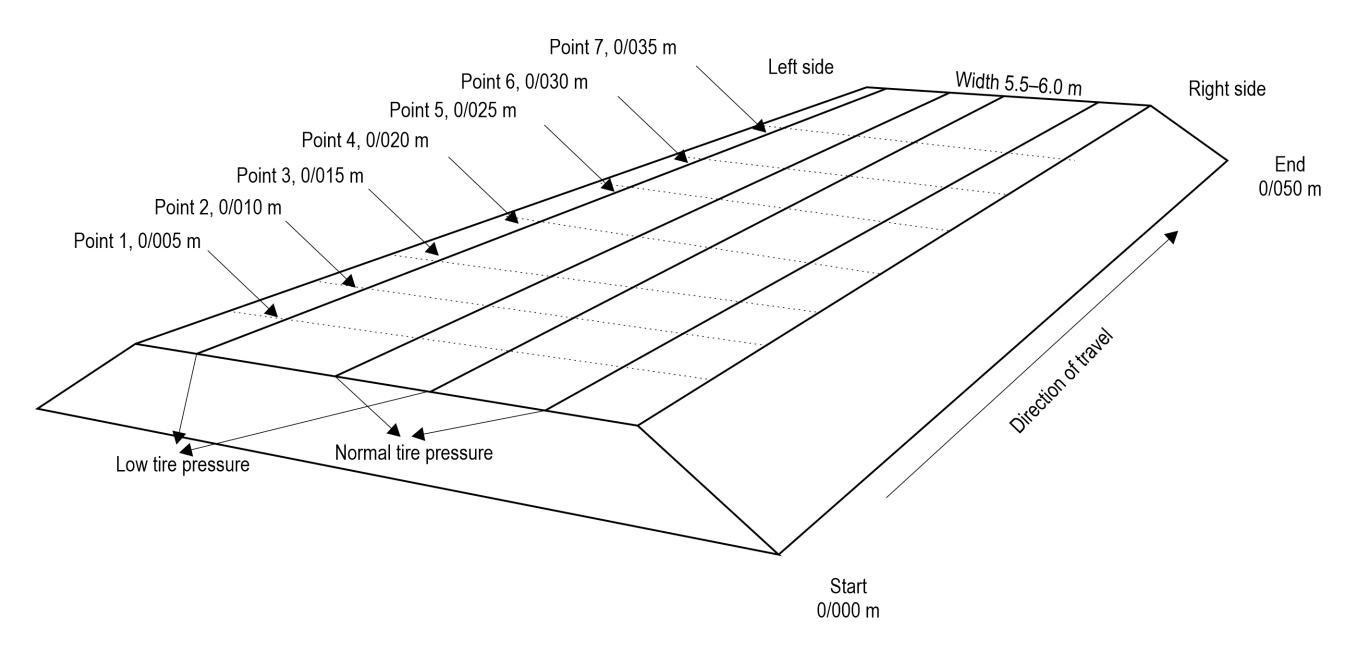
Fig. 4 Location of truck paths and measurement points in a road section. Measurement points are located at the same distances in the right wheel path for the normal tyre pressure treatment as for the low tyre pressure treatment in the left wheel path

Measurements were taken at 14 points in each road section, seven on each side of the road (Fig. 4). Points 1L and 1R were placed 5 m after the start of the section with subsequent points every fifth meter. Normal tyre pressure test points on the right side of the road and low tyre test points on the left side, seen in the direction of travel. No measurements were taken in the central wheel paths.

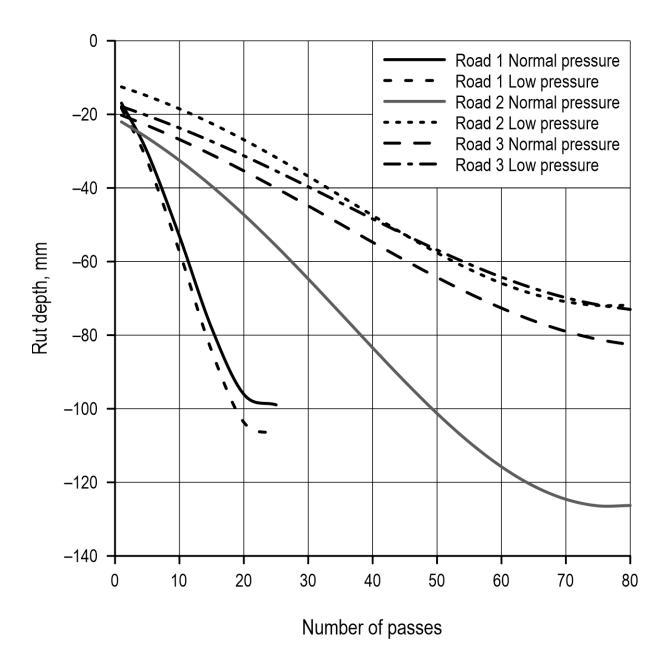
Fig. 5 Rut depth development by number of passes for roads with uncompacted surface layer

On September 22, 2015, the rut formation test was carried out on Road 1. The terrace had not dried out, indicated by standing water in the ditches, which led to a weak road. Ruts developed quickly both at normal and low tyre pressures. In some places, deep ruts formed as a combination of deep subgrade failure and road shoulder shearing failure. After 28 passes at normal highway tyre pressures, deep ruts in a rupture on Section 5 caused the truck to nearly overturn, which led to an immediate stop of further testing for the sake of safety. No significant effect of CTI was found for Road 1, which was wet and constructed of silty sand (Table 2). In the range from 1 to 15 passes, the modelled difference in rut depth between low and standard highway pressures are smaller than 7 mm, which is practically negligible and not statistically significant (Fig. 5).

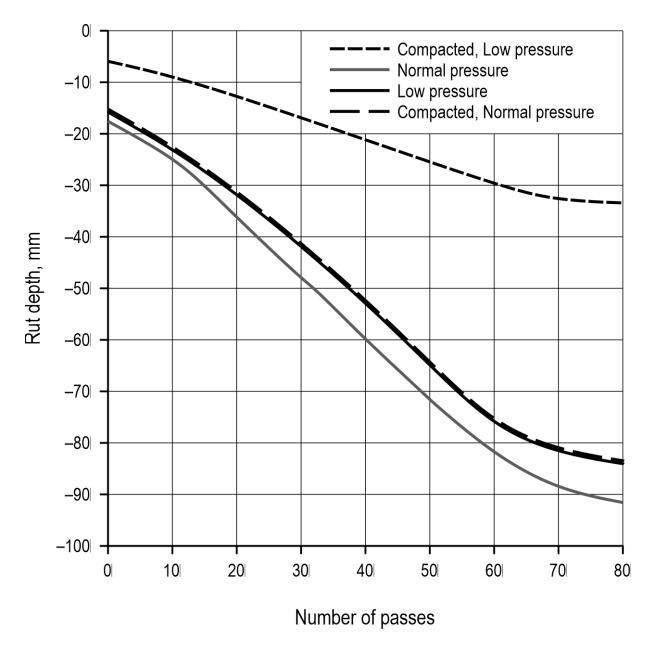
Fig. 6 Rut depth development by number of passes for Road 3

For Road 2 and the sections of Road 3 with uncompacted surface, the use of a low tyre pressure reduced rut development (Table 2), although only significantly so for Road 2. Here the difference in rut depths after 75 passes between low and standard highway pressures is 54 mm for Road 2 and 10 mm for Road 3. However, if considering the surface layer compaction made on three of the sections in Road 3, model 2 (Table 3) shows that there is a clear positive interaction effect between tyre pressure and surface compaction. Thus, the combination of low tyre pressure and surface compaction strongly reduced rut development. In this extended analysis, the difference in rut depth after 75 passes between the low and standard highway pressures is a negligible 7 mm on the uncompacted sections, while it is 50 mm on the compacted sections (Fig. 6).

On Road 3, rut depth development was significantly affected by an interaction between tyre pressure and compaction of the road surface. As shown in Fig. 6, the combination of low tyre pressure and compaction of the surface favour the reduction of rut development. However, this effect is influenced by the soil type as the surface layer compaction increased the CBR values in the terrace by 66% on the sandy sections and only by 10% on the gravel sections. Furthermore, some of the initial rut formation on the uncompacted sections is caused by the test vehicles compaction of the gravel layer.
